**LABORATORY PMU TEST REPORT  
FOR THE MOCK-UP WALL SYSTEM**

**ISEAL EP SYSTEM MOCK-UP**

File:  
**AC-00300-A**

Toronto, Date: February 5, 2020

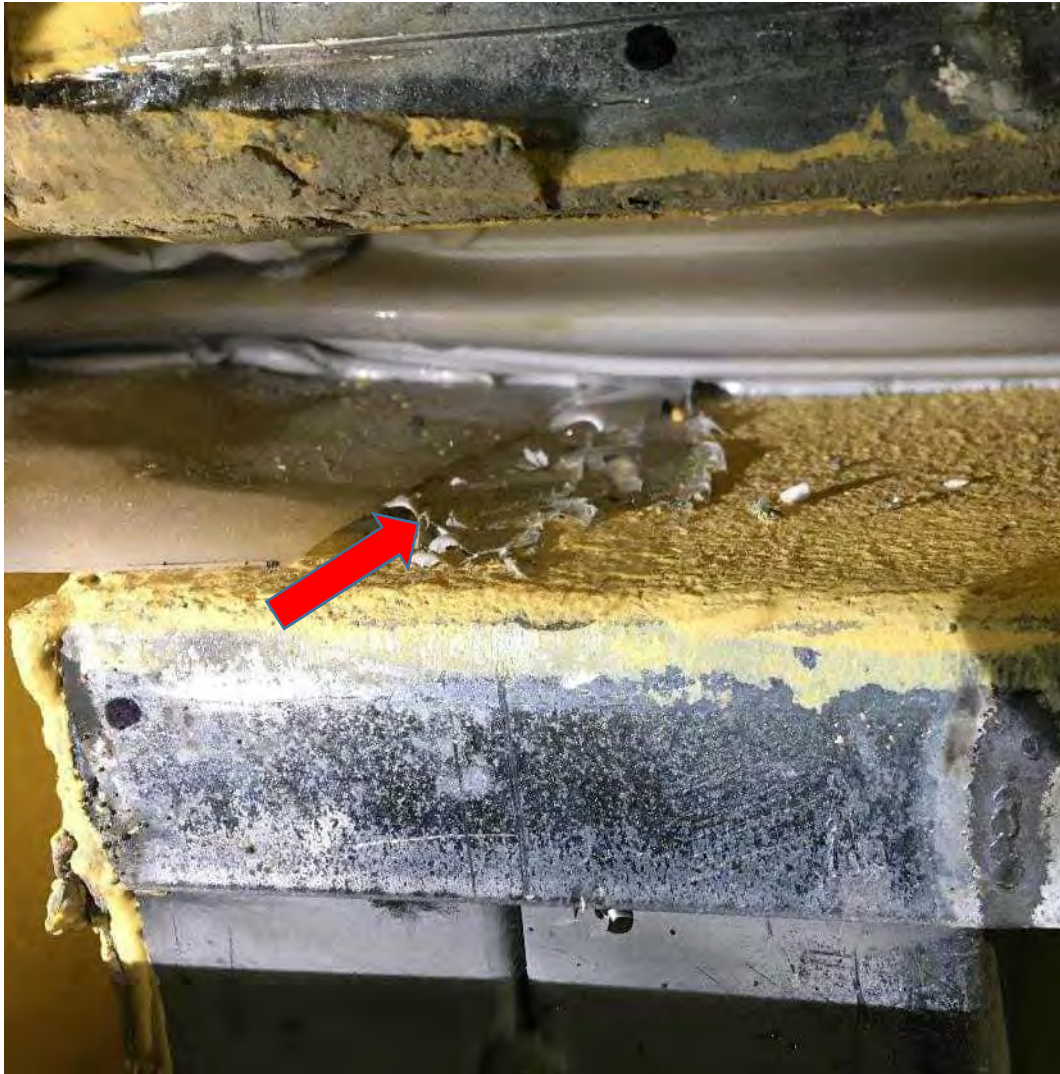
<p><b>Observation:</b></p> <ul style="list-style-type: none"> <li>- Water leakage was observed through the four-way joint. <b>(See figure B4).</b></li> </ul> <p><b>Remediation:</b></p> <ul style="list-style-type: none"> <li>- The four-way joint was resealed with Dow 995 sealant at the interior face <b>(See figure B5 and B6).</b></li> <li>- The upper panels were lowered by 1/4" to compress the horizontal expansion joint.</li> <li>- Prior to pre-load test, additional support brackets were added to each panel's receiving connection at the horizontal joints and fastened to each existing support bracket <b>(See figure B7).</b></li> <li>- The upper panels were lowered by an additional 1/2" to further compress the horizontal expansion joint.</li> </ul>

Photo B4: Water penetration through four-way joint during static water penetration test (Test procedure 2.3a).

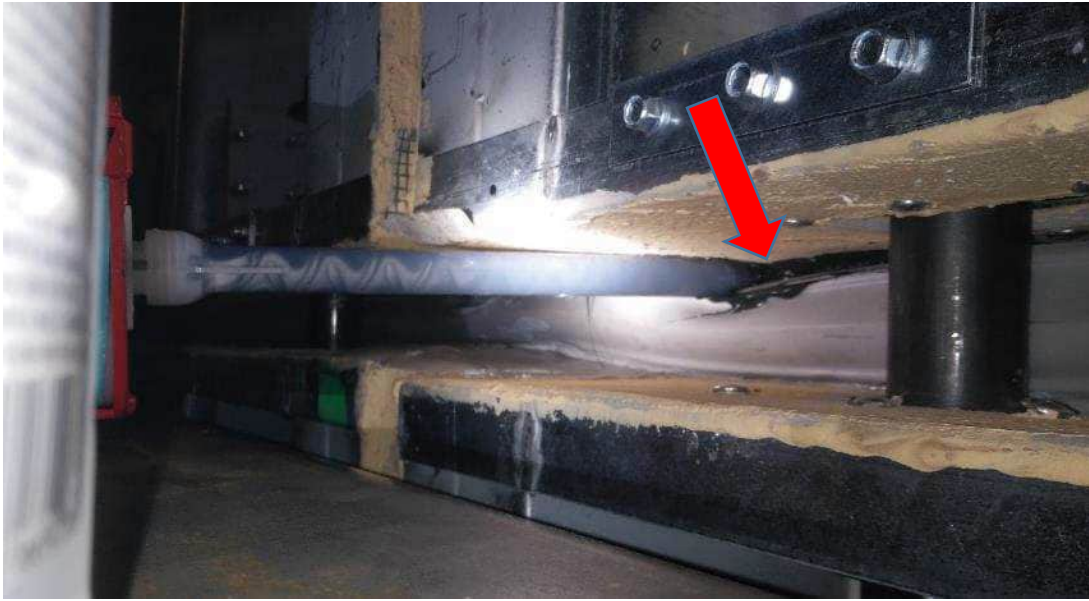
Photo B5: Remediation: Four-way joint was resealed with Dow 995 sealant from the interior side  
“Prior to section 2.1B, Preload”

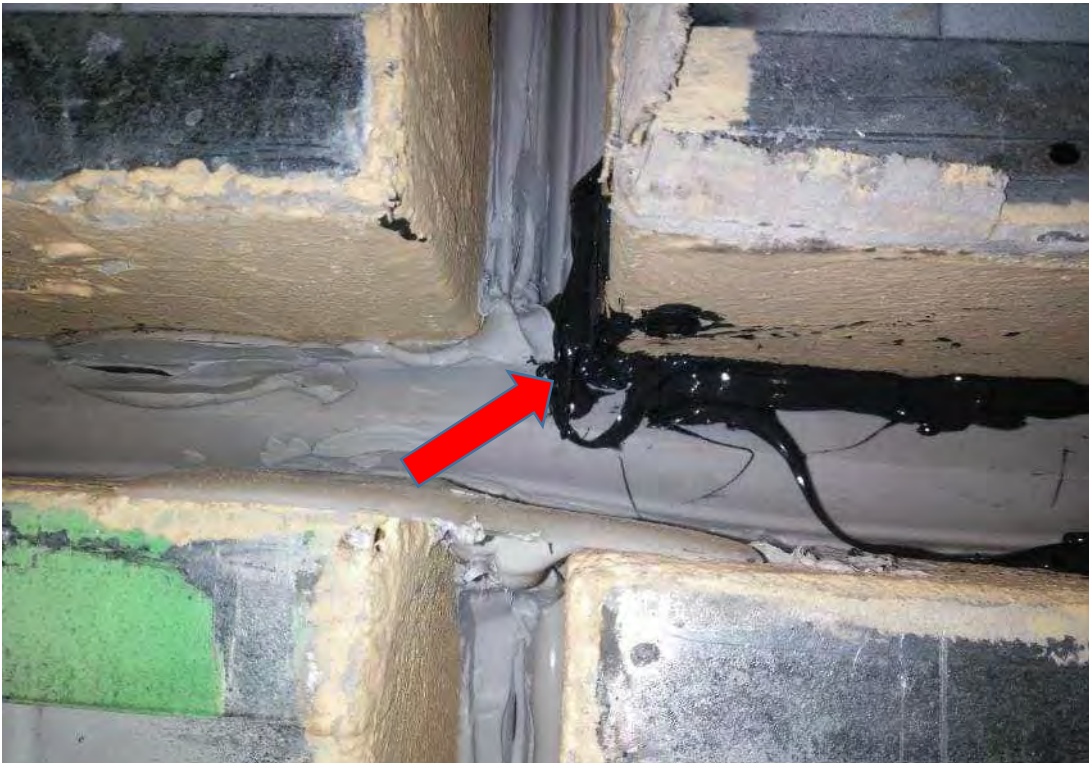
Photo B6: Remediation: Four-way joint was resealed with Dow 995 sealant from the interior side  
“Prior to section 2.1B, Preload”

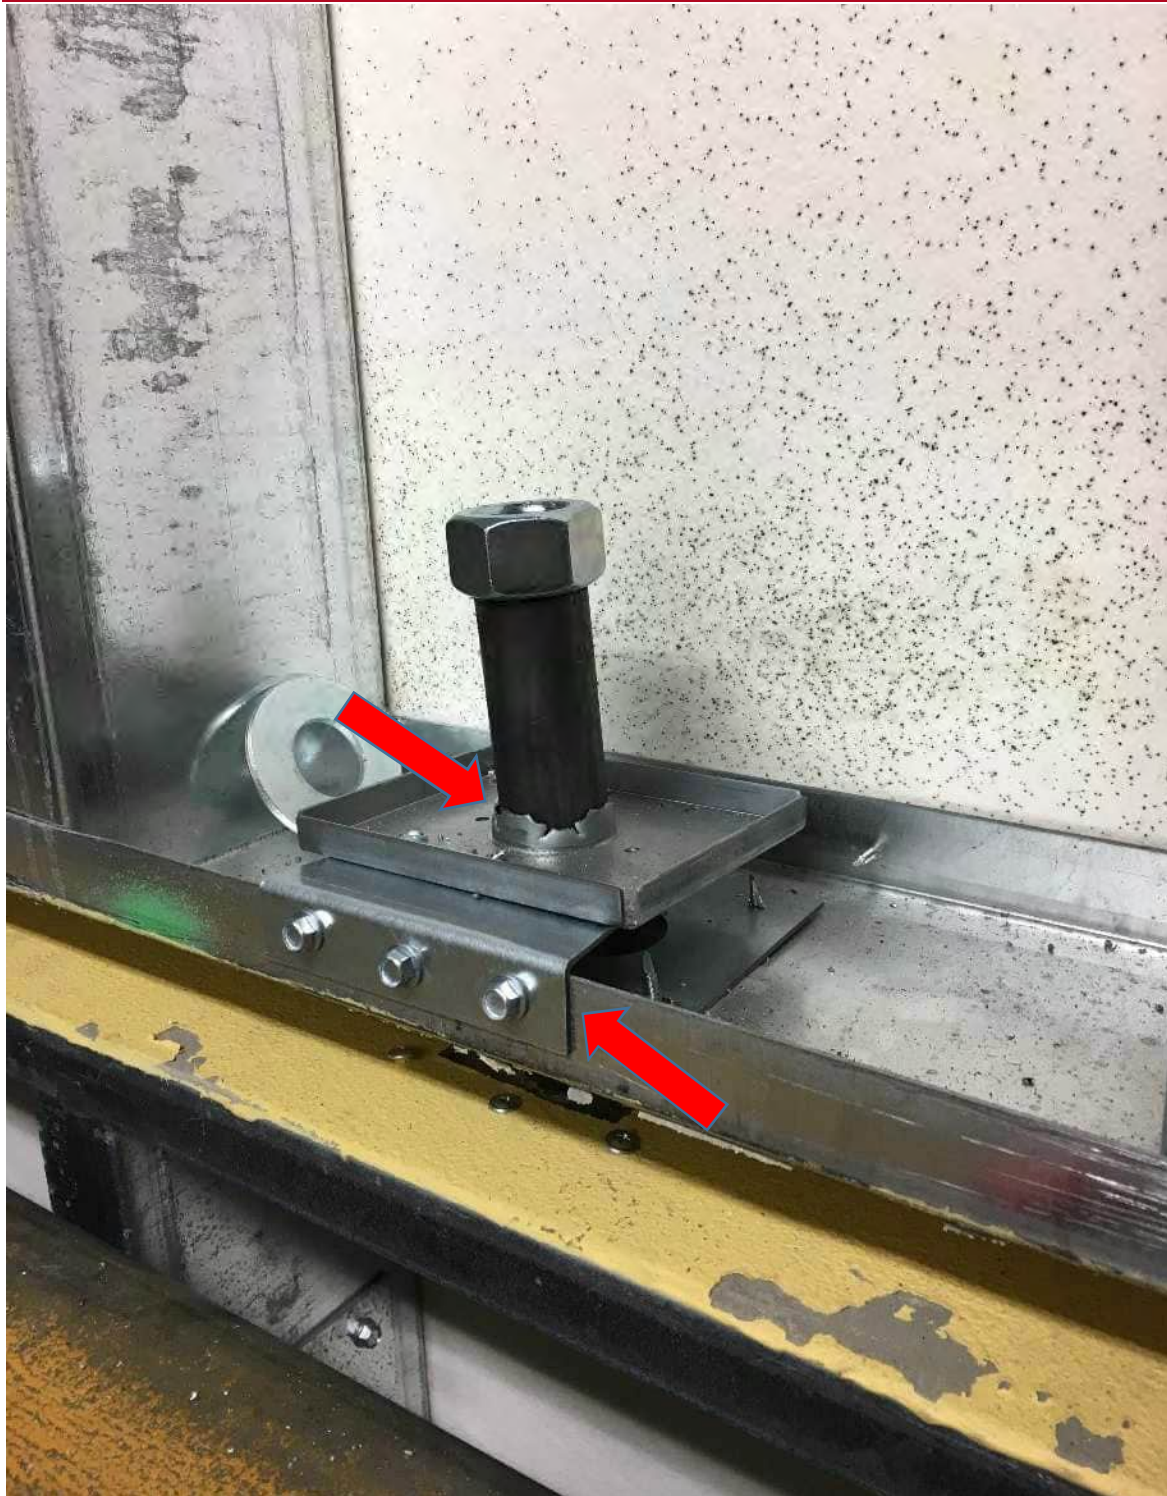
Photo B7: Remediation: Additional safety support brackets for each panel to panel sliding pin connection at the horizontal panel to panel joint. Fastened at each existing support bracket.

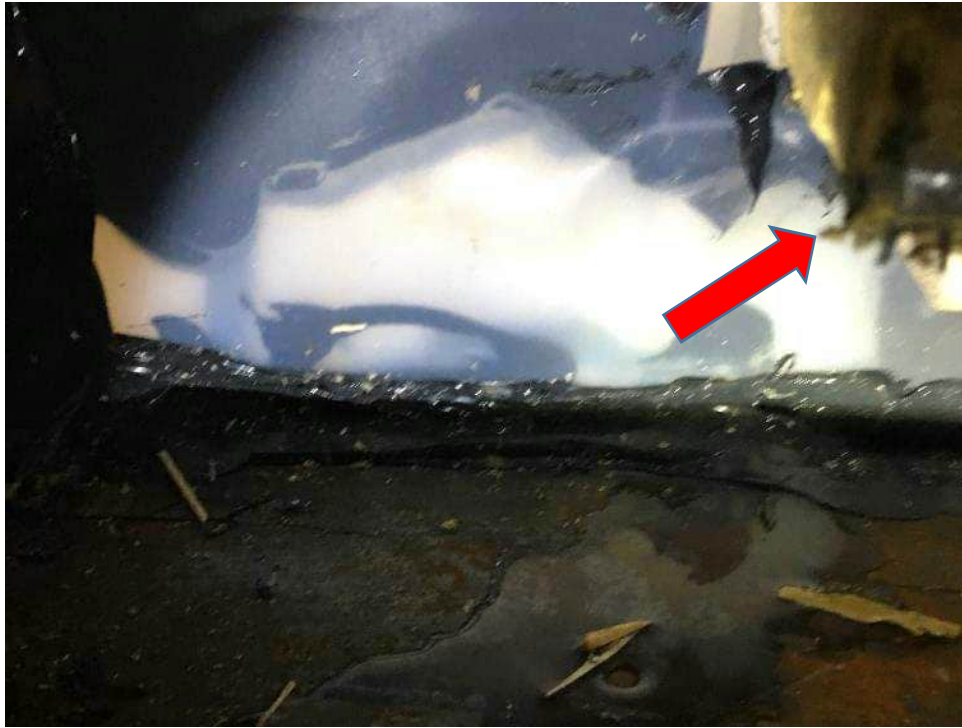
Photo B8: Water Leakage along the left (from exterior) transition membrane sealed joint.

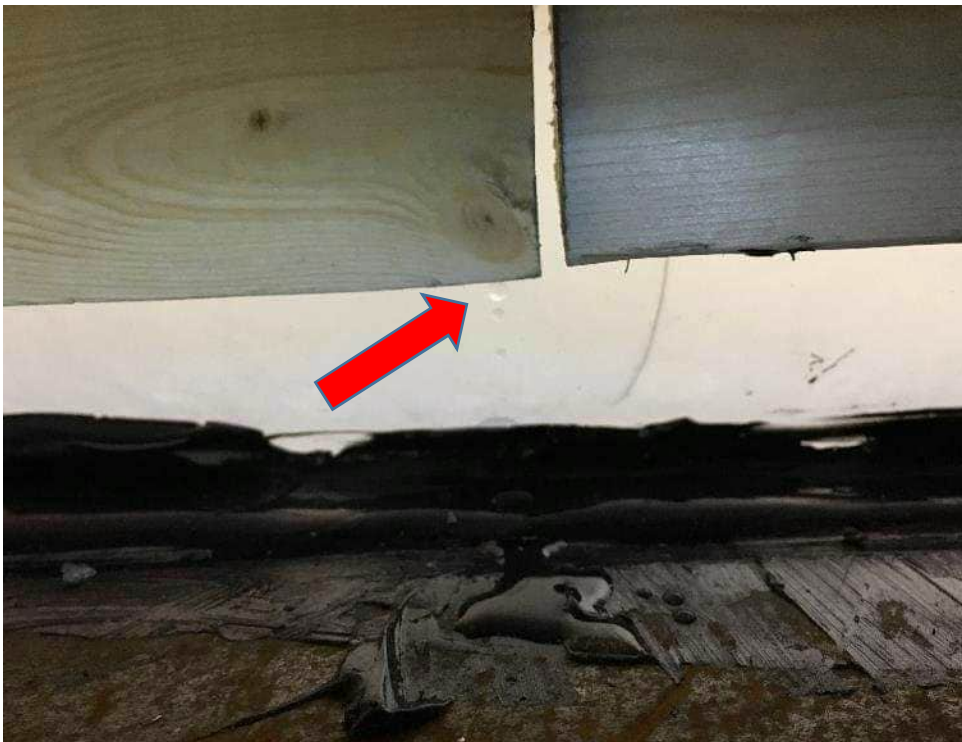
Photo B9: Water penetration over the sill at the mid span of the lower full size panel.

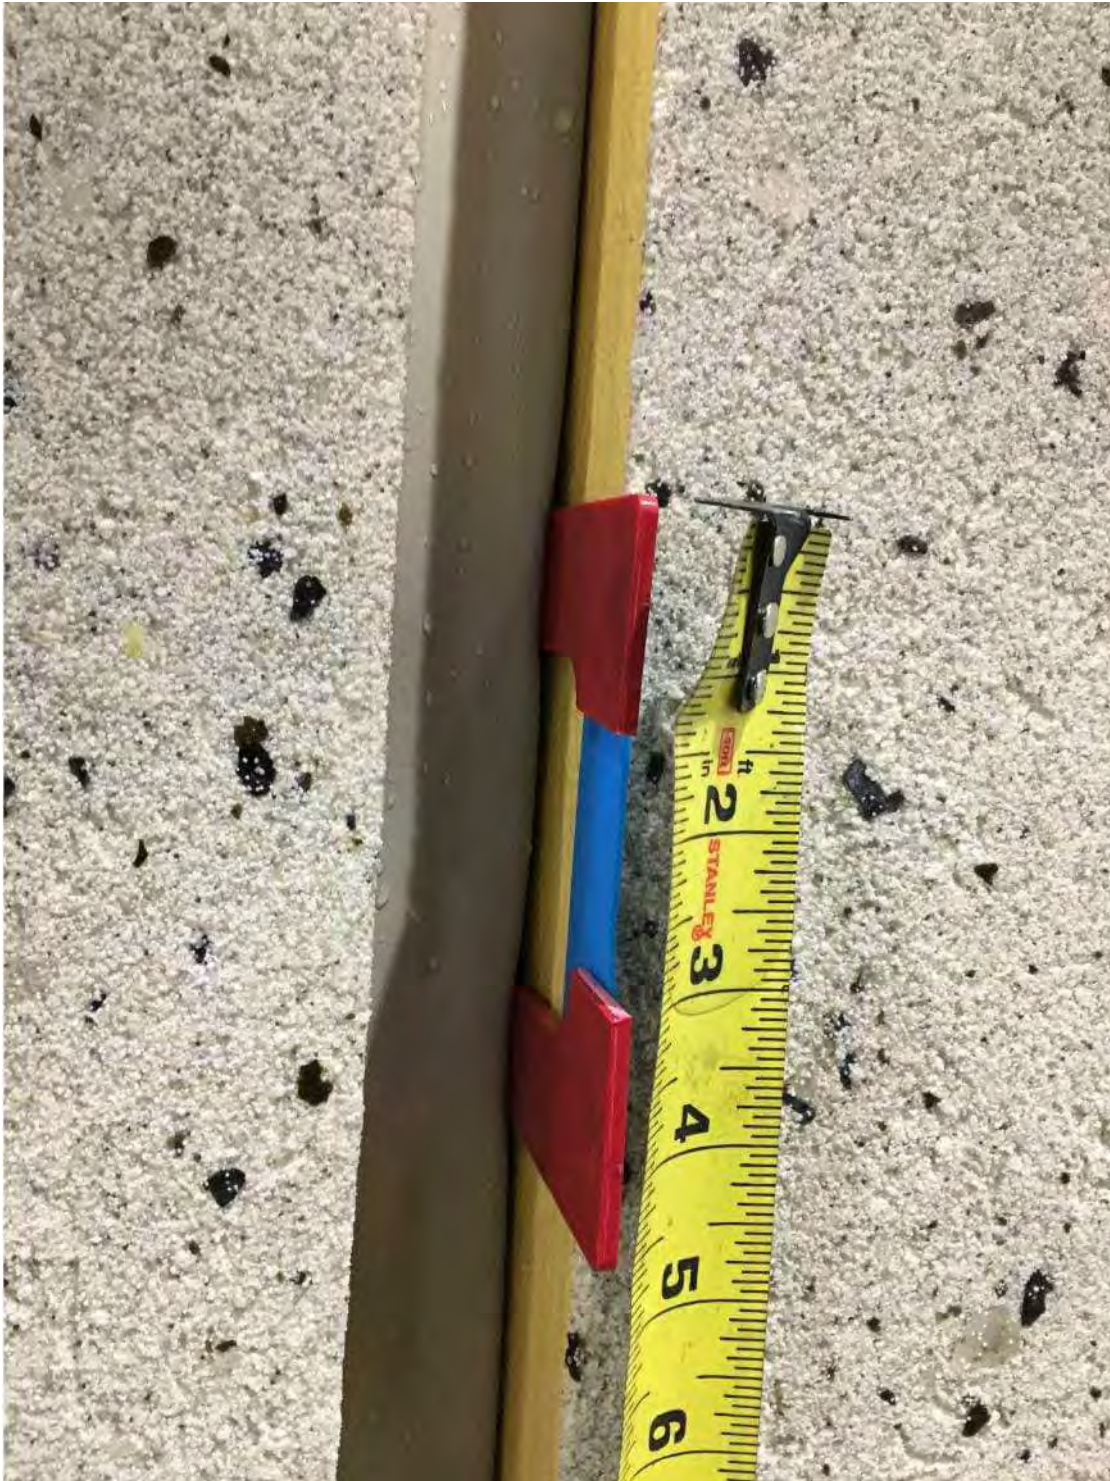
Photo B21: At 32 inches above the horizontal expansion joint two 1/8 inch shims were inserted into the vertical expansion joint seal at 4.5 inches apart to simulate a defective seal "Prior to section 2.14 Water Penetration Test "
