**LABORATORY PMU TEST REPORT  
FOR THE MOCK-UP WALL SYSTEM**

**ISEAL EP SYSTEM MOCK-UP**

File:  
**AC-00300-A**

Toronto, Date: February 5, 2020

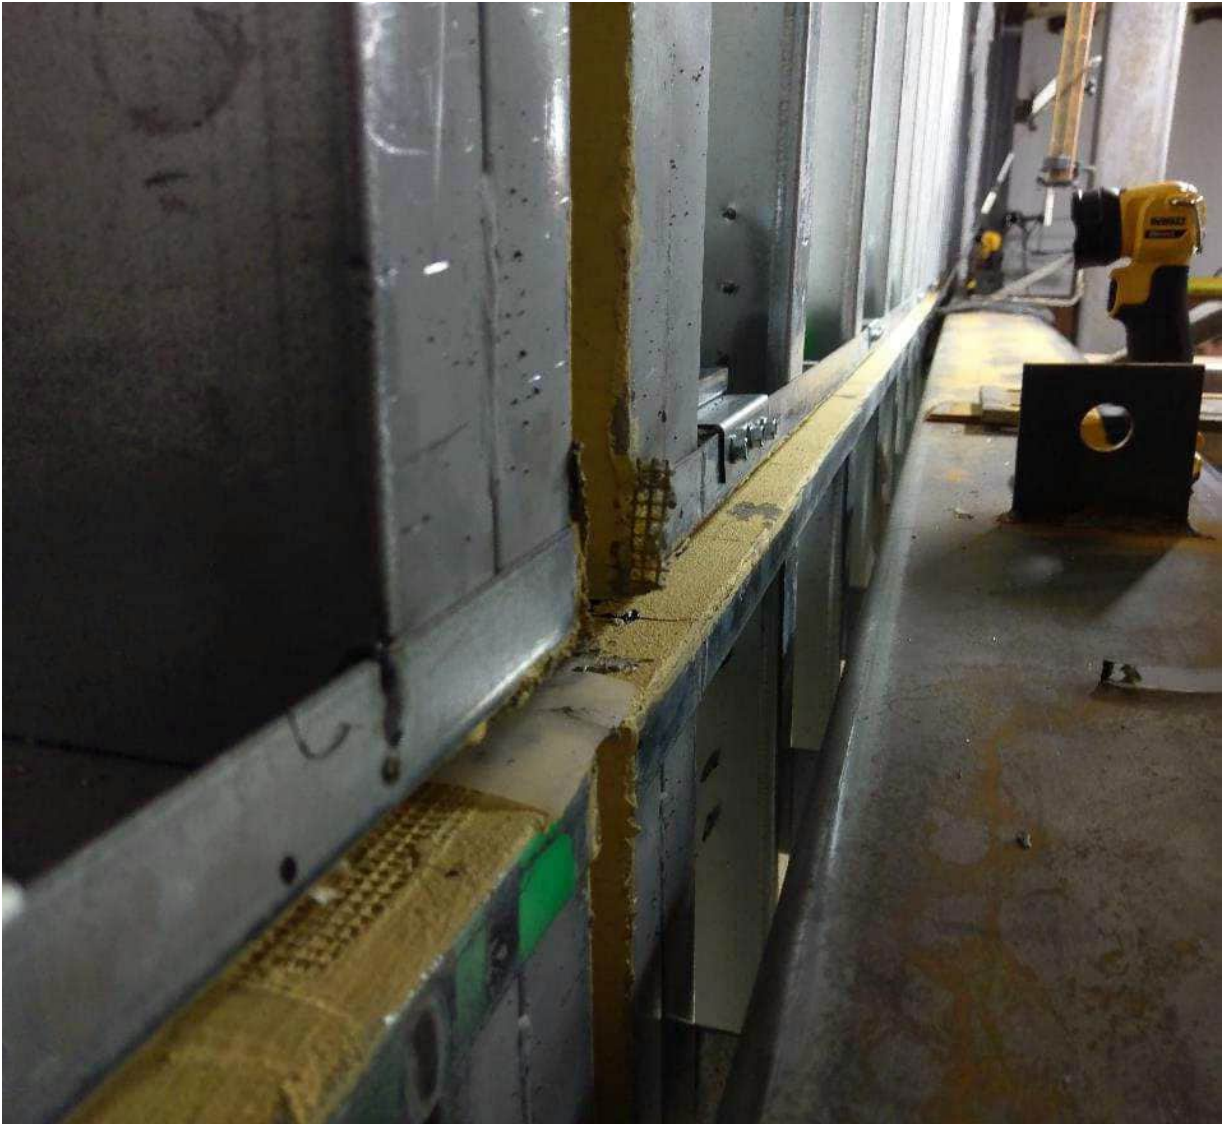
Photo B16: Interstory horizontal (in/out) movement test, 1.45" outwards

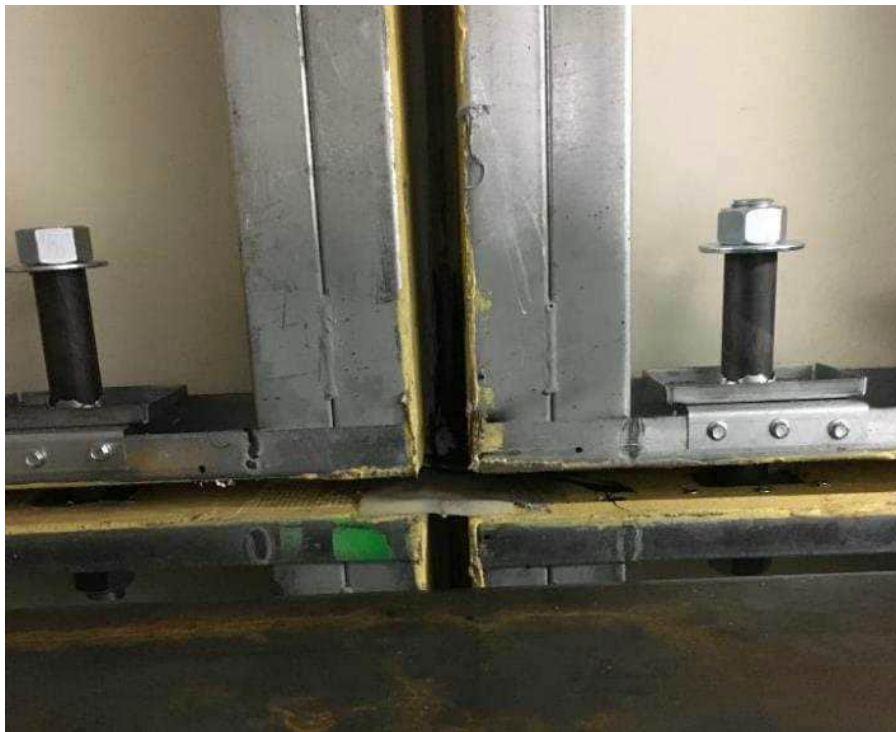
Photo B19: Interstory vertical (up/down) movement test, 0.75" downwards
